Module #6 Cold Mass Assembly Outside of the Clean Room

Tug Arkan, Don Mitchell

Week-III

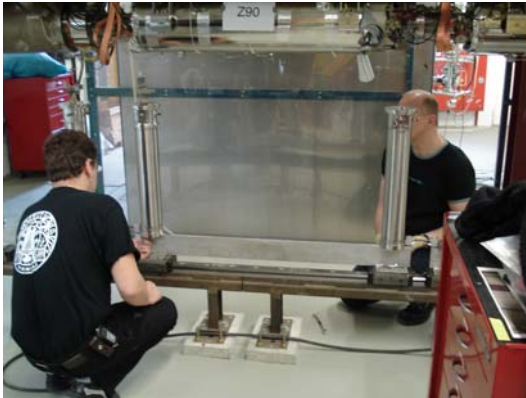
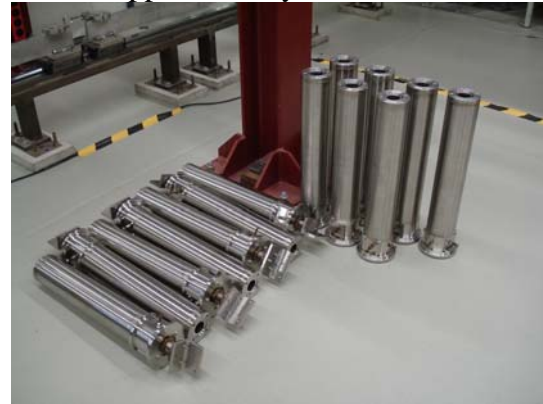
Technicians removed all of the cavity support posts and related hardware from the rail after the cavity string was attached to the cold mass support on Day 7.

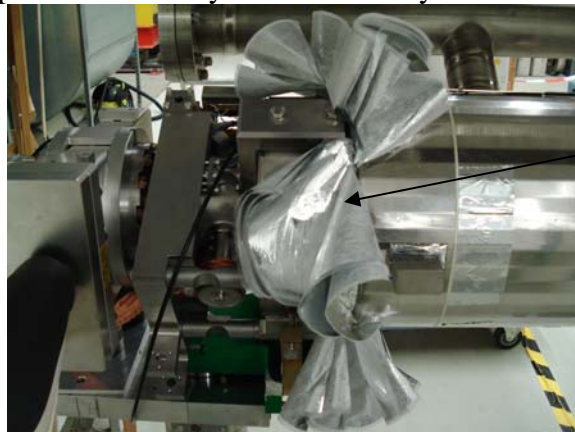
They tucked in and taped insulation layers on the cavity tuner end.

Before the
insulation was
tucked in

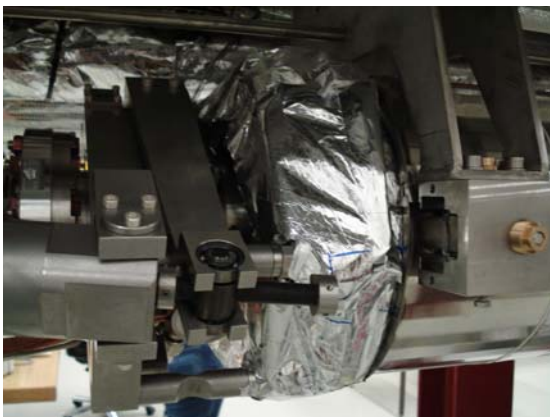
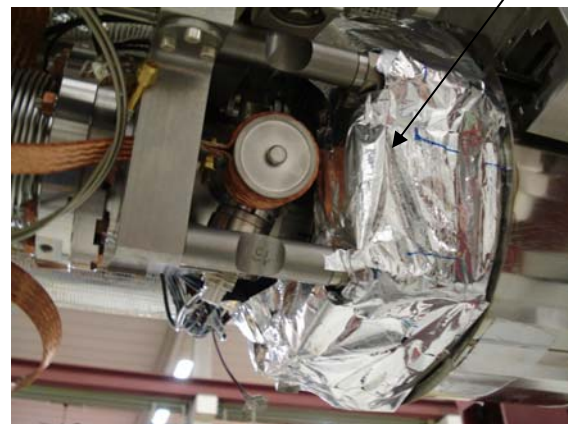
After the
insulation was
tucked in and
taped

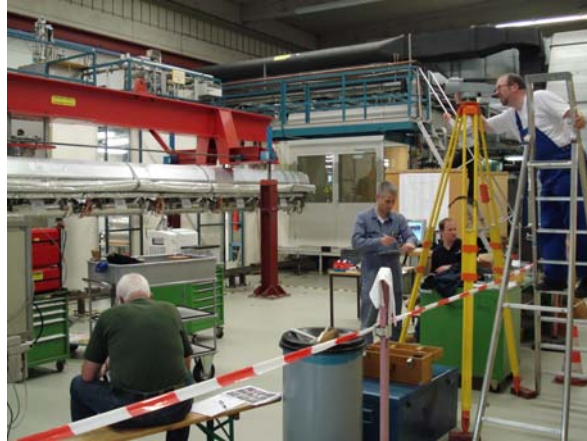
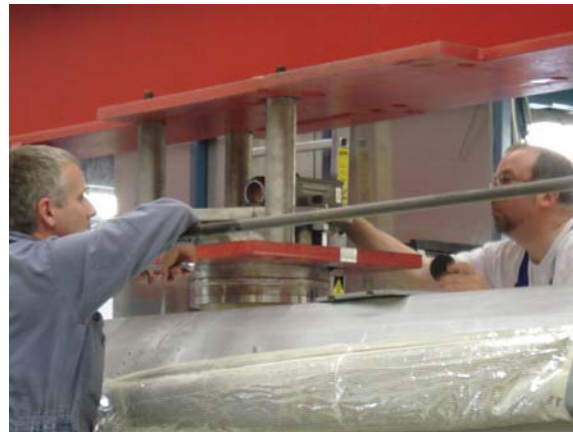
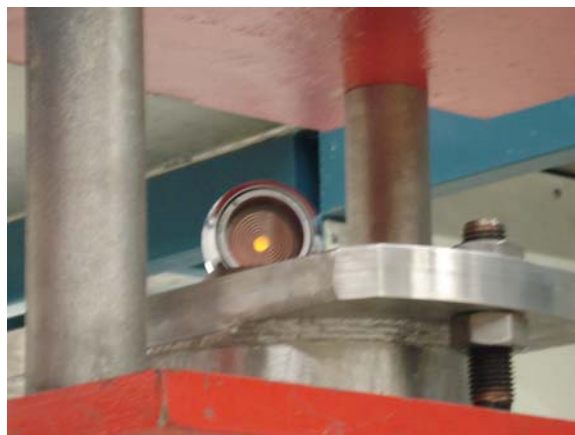
DESY laser survey crew arrived and started to setup their laser tracker equipment. They inserted Taylor-Hobson alignment references in the 3 cold mass support posts. They used standard optical scopes to align the Cold Mass only. They adjusted the nuts on the cold mass support posts until the supports were leveled with each other and without twist. This “tweaking” caused the cavity string to move slightly. During future alignment, the cavities will be re-aligned. The cold mass was aligned to ± 0.3 mm with the optical scopes.

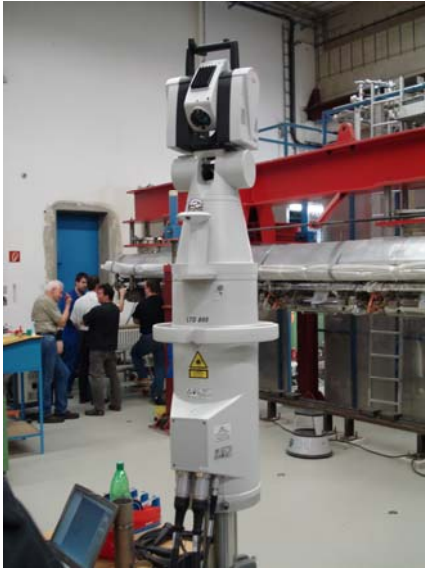
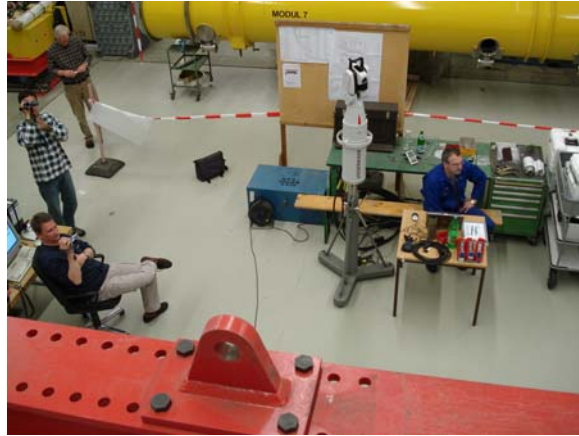
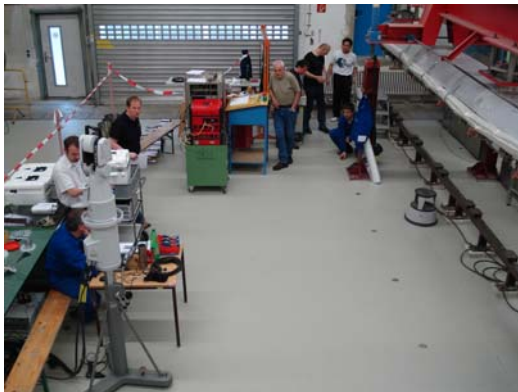
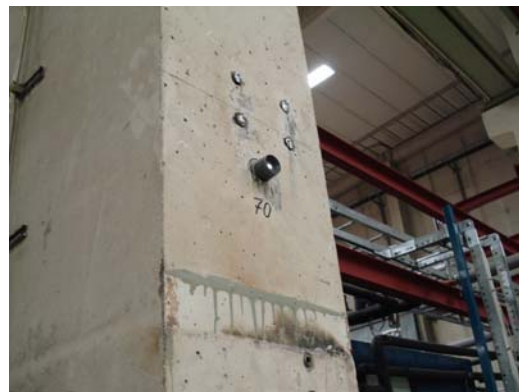
Survey crew continued to set up and calibrate the laser tracker system. They have previously placed fiducial mounts in many locations (floor, walls) in Hall 3 near the cold mass assembly area. Approx. 20 locations on the floor and about 6 locations on the walls were used.

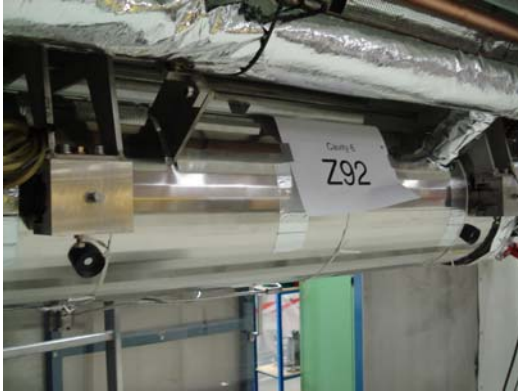
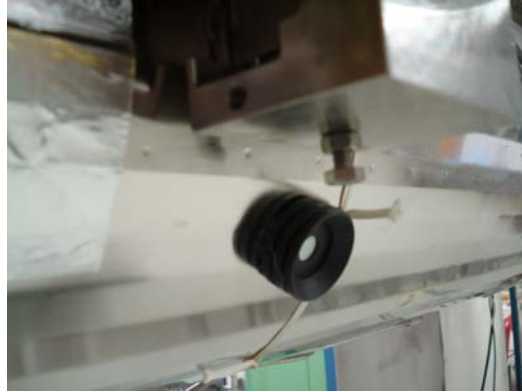
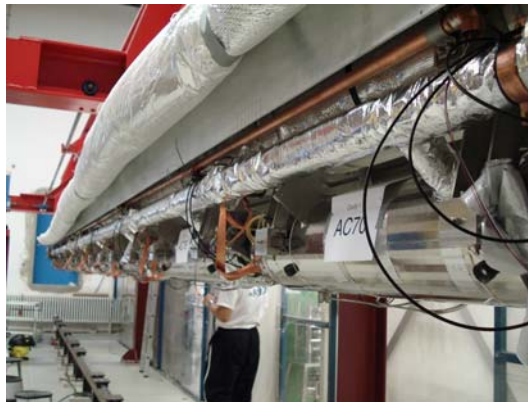
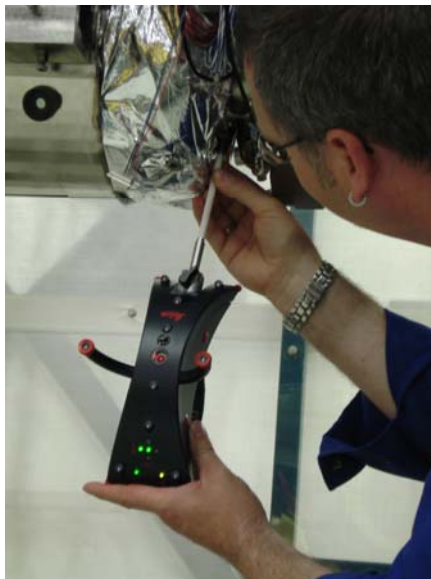
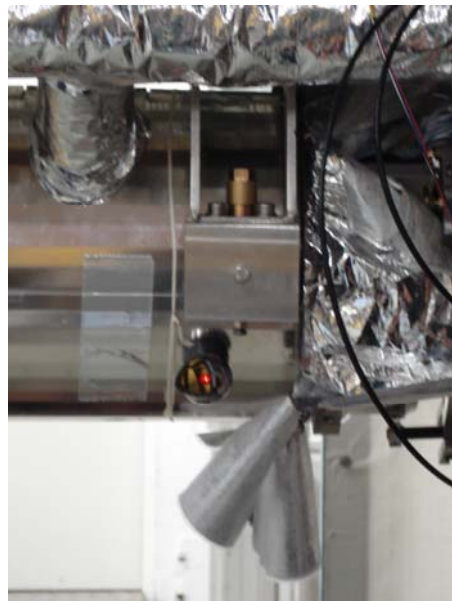
They glued onto the magnetic shield, 2 fiducials per cavity. These 2 points were used as transfer points from the cavity alignment flanges / rings. Direct, line of sight to the alignment flanges / rings is impossible, so the flange / ring locations were read around the perimeter of the ring using a stick probe laser reflector and translated to the magnetic shield fiducials.

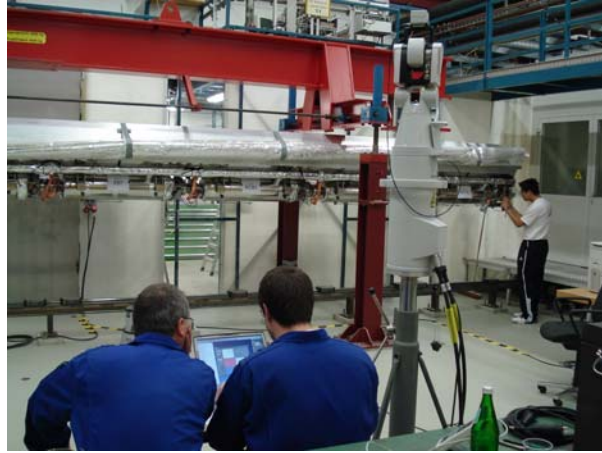
This was the first time that DESY used a laser tracker system to align the cavity string to the cold mass support. Calibration and verification took all of day 9. They worked on Cavity #1 alignment all day to ensure that the alignment technique and laser tracker system was working properly.

The alignment was done by loosening the brass screws on the cavity support lug needle bearing blocks and turning the adjustment screws until the X-Y displacements were within the acceptable range (± 0.1 mm). This adjustment was real-time and they were reading the displacements from a laptop while turning the screws on the needle bearing block.

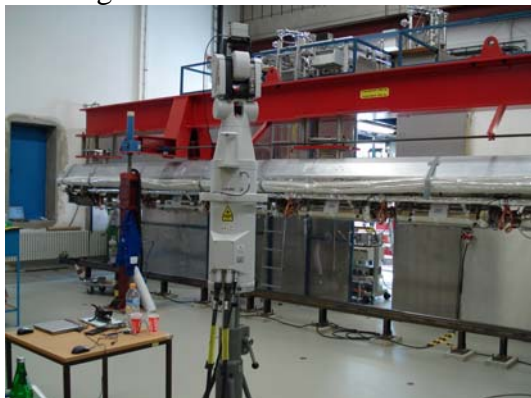
Survey crew aligned the remaining cavities with the laser tracker. Technicians turned the brass screws on the needle bearing supports until the read-outs of the laptop screen showed they were within the required tolerance of $\pm 0.1\text{mm}$.

This work took all day. No other components were attached to the cold mass during the survey procedures. All crane activity at Hall 3 was suspended to reduce vibrations in the building.

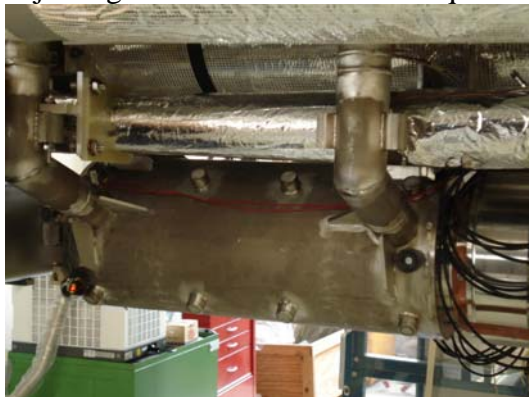
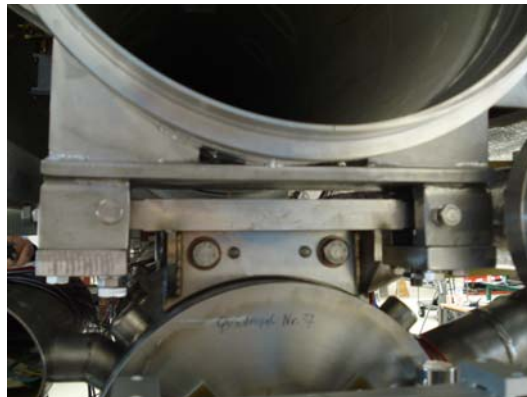
They also aligned the BPM/Quadrupole package. Module #6 does not have needle bearing supports for the Quadrupole support to the cold mass. So the alignment was done by adjusting the screws that hold the quadrupole to the cold mass.

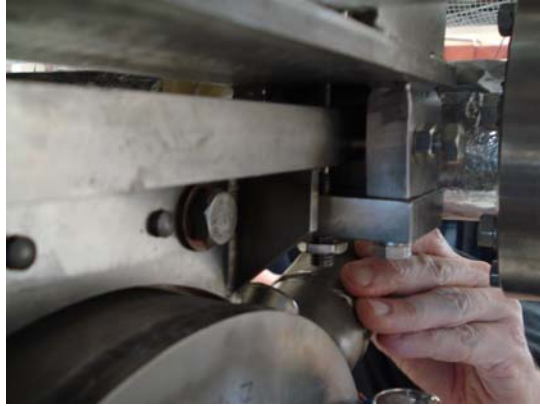
Survey group worked late until 9.00pm on Day 10 to finish the alignment of all the 8 cavities and the quadrupole magnet.

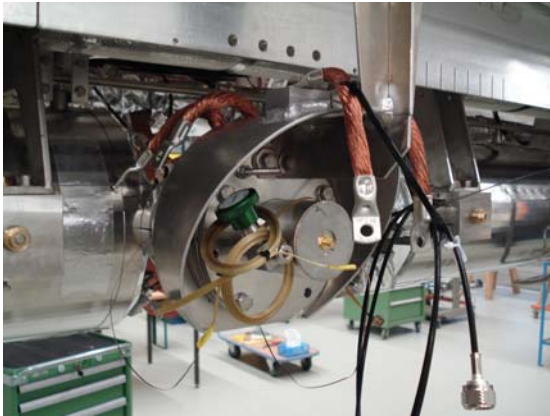
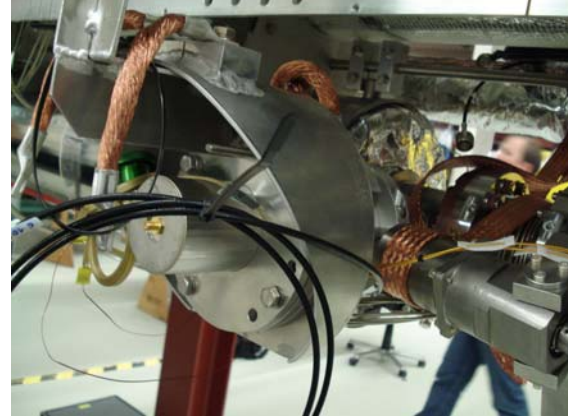
Technicians mounted the heat shields (cones) on the cavities main coupler flange.

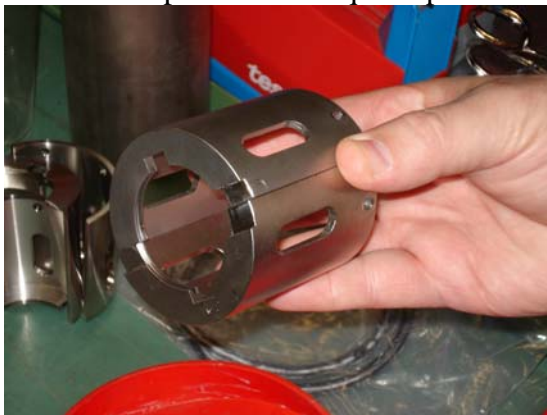
The main coupler bellows squirm protection hardware was removed.

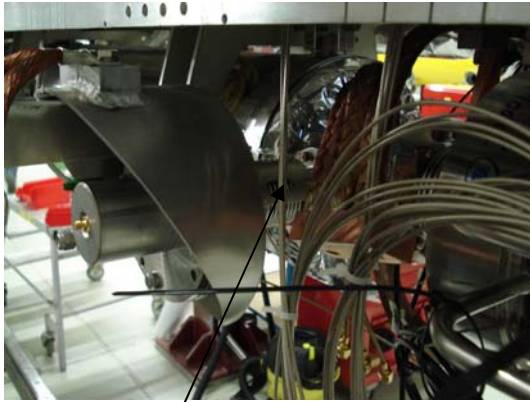
Squirm protection hardware

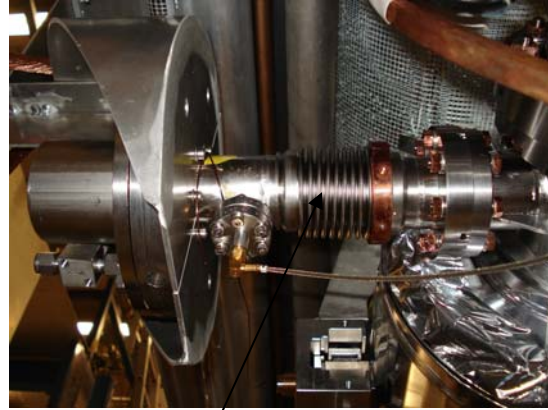
Squirm protection hardware removed

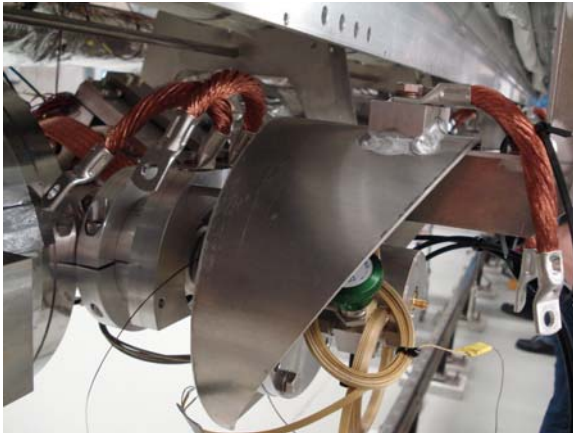
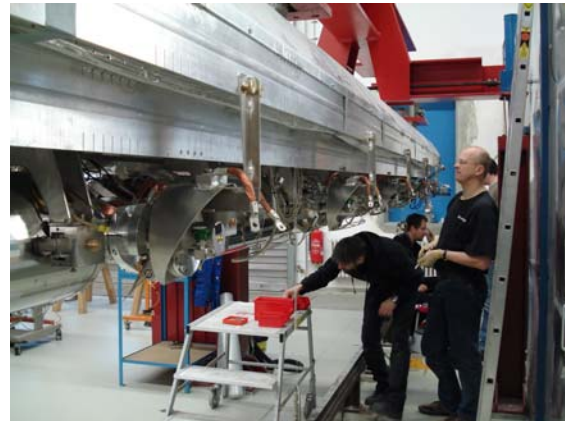
Heat sink collars were installed onto the main coupler after the bellows squirm protection hardware was removed. The collars have 2 copper cables that connect onto the 4K shield on the cold mass.

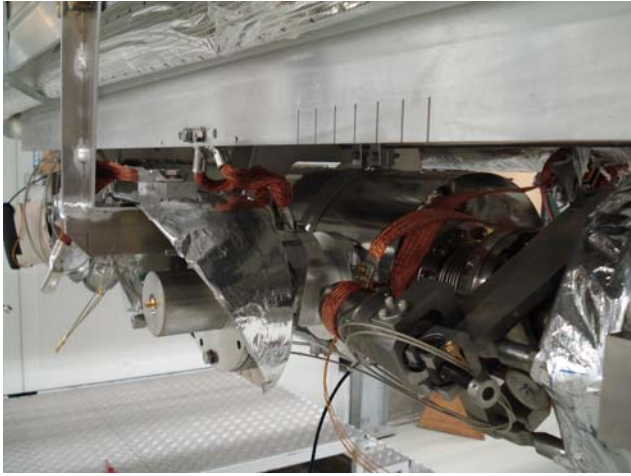
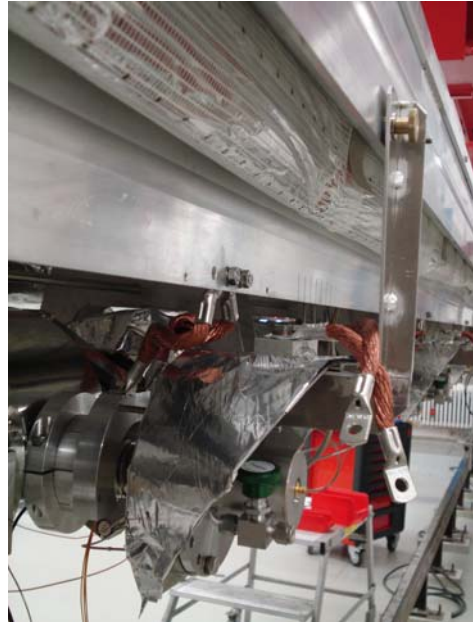
The cones were wrapped with 5 layers of insulation. These cone shields have 2 copper cables that connect to the 80K heat shield of the cold mass.

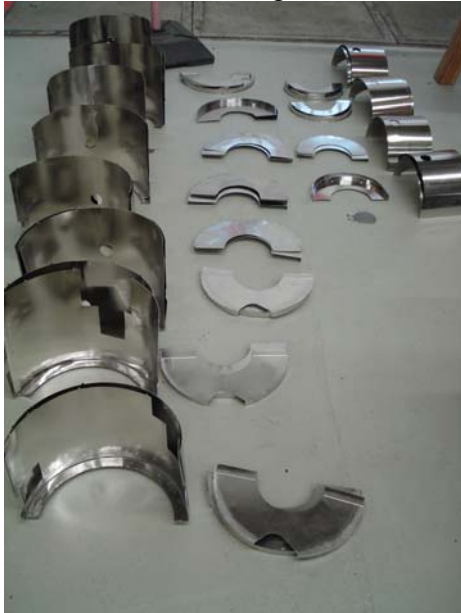
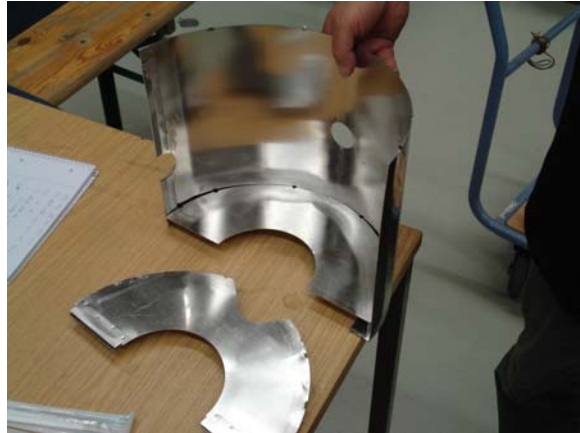
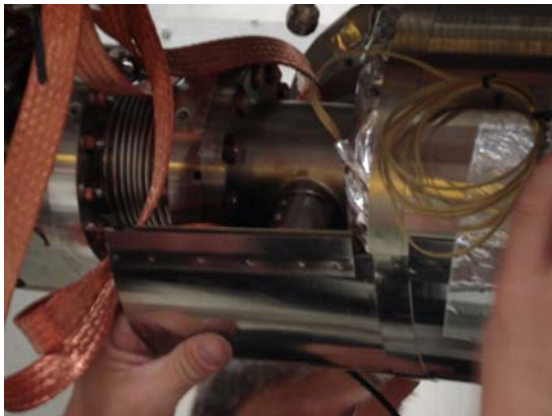
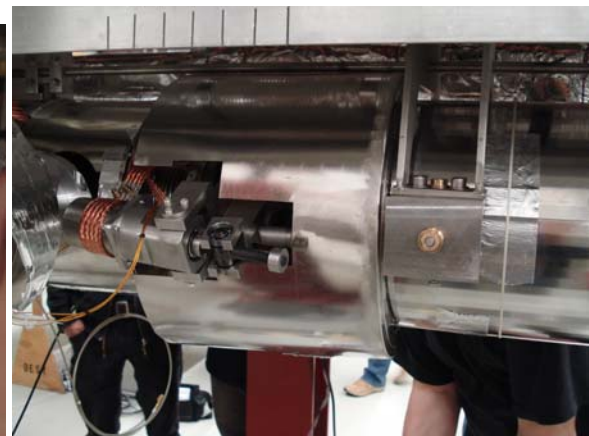
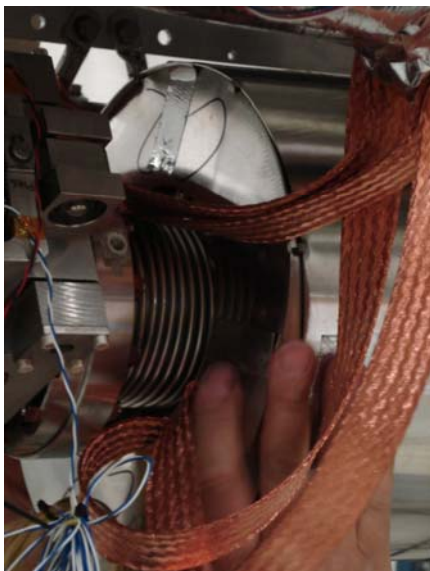
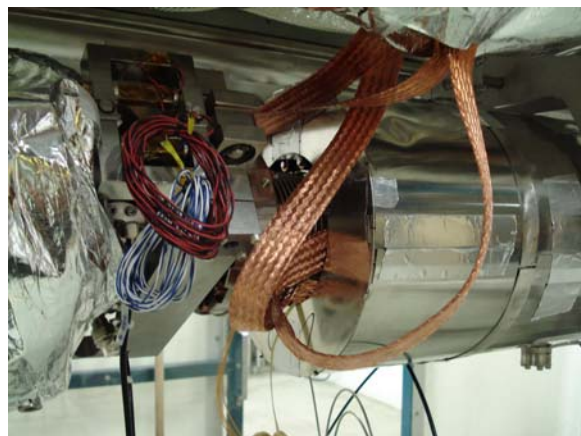
Technicians installed magnetic shield on the end of the cavities.

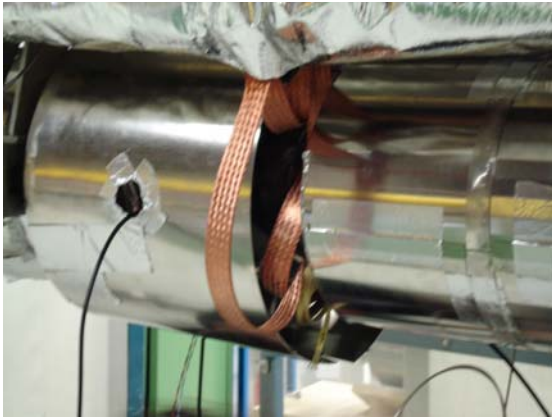
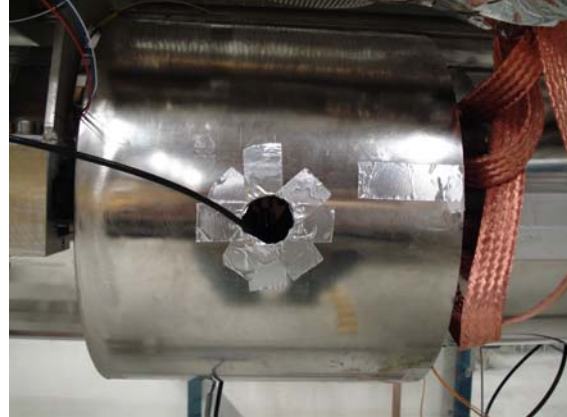
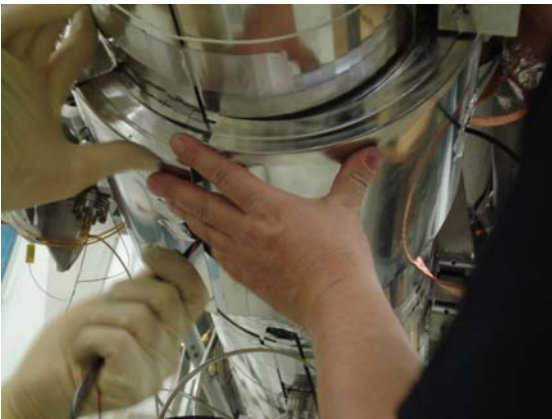
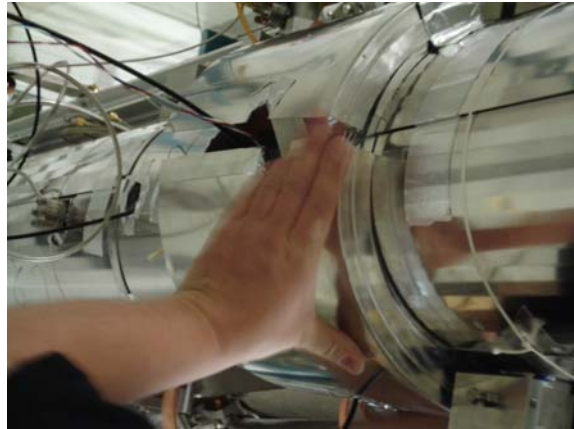
Read-out cables were routed through the cutouts on the magnetic shields. Aluminum tape was used to eliminate sharp edges on the cutout of the shields.

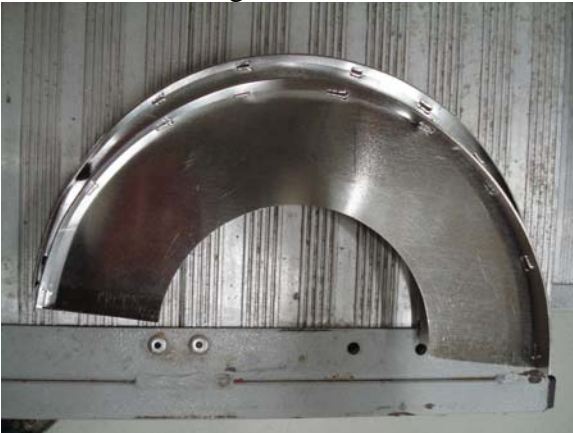
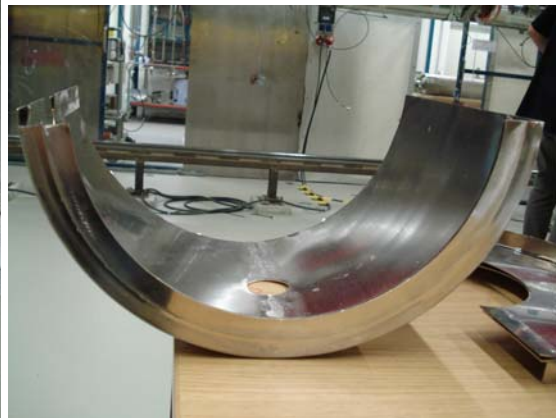
Some shields were not fitting well, so the double layer joints were pried open slightly to allow the shielding to interlock.

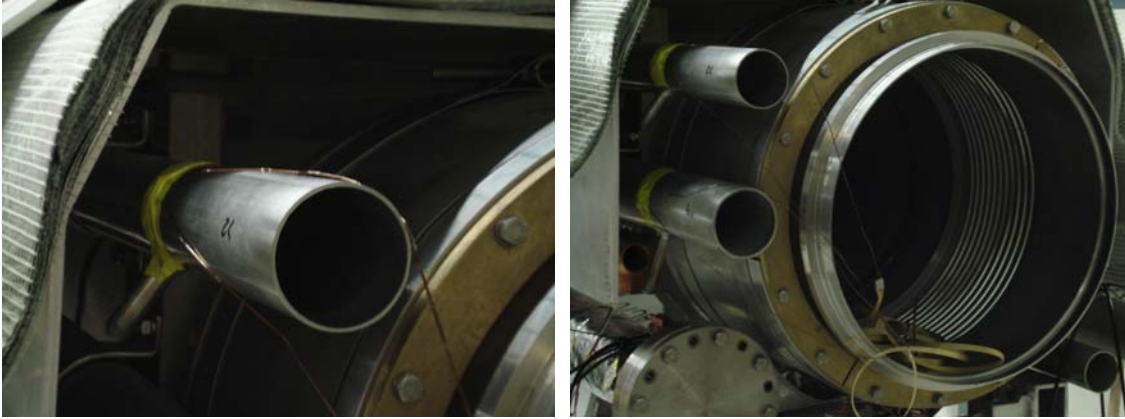
A technician installed thermo-couples on the cryogenic supply pipes of the cold mass. He used a black epoxy glue to glue the thermo-couples around the pipes.

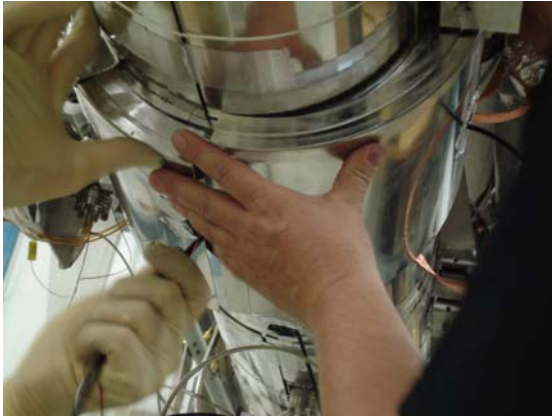
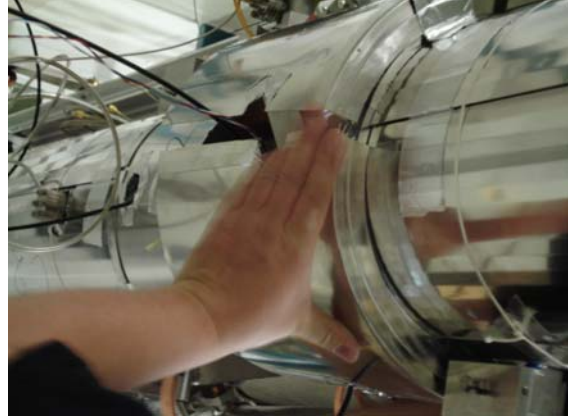
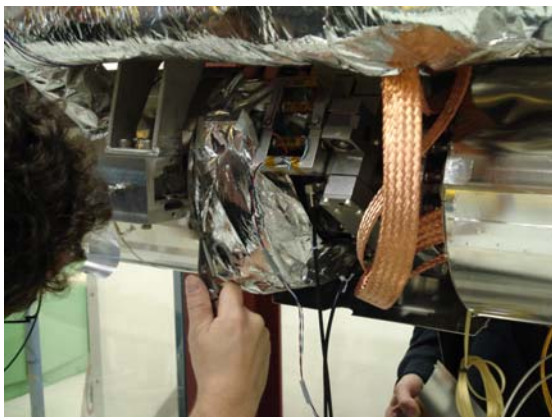
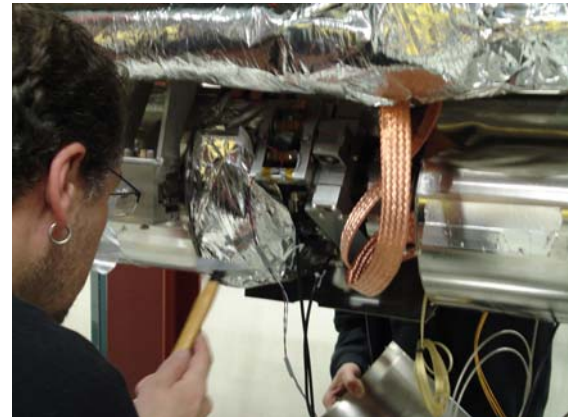
Technicians installed the remaining magnetic shields on the cavity ends. Most shields were difficult to fit. Technicians had to use a hammer and pliers to try to fit some shields.

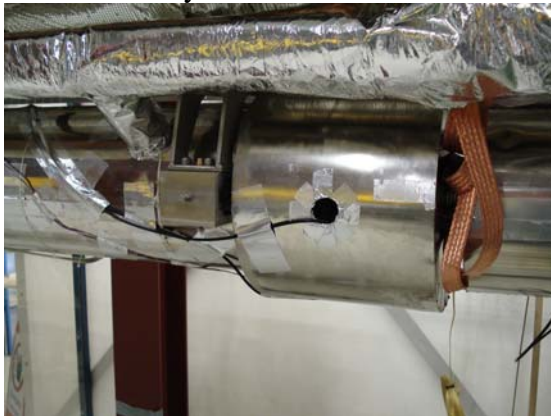
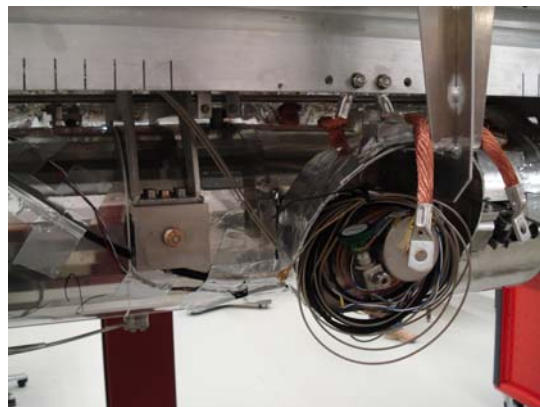
Technicians routed all of the cables & wires and used aluminum tape to hold the cables in place around the magnetic shields. The wires were wrapped in a spiral pattern around the magnetic shield. Finally, the wires and cables were coiled into a circular bundle and placed around the end of the main coupler of each cavity. The wires and cables were left there so that they will be accessible once the cold mass is inserted into the vacuum vessel.

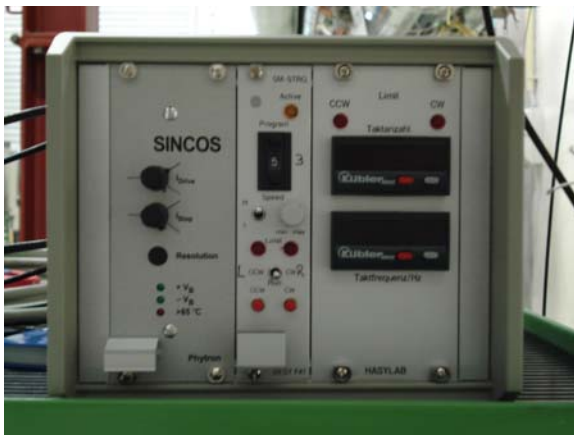
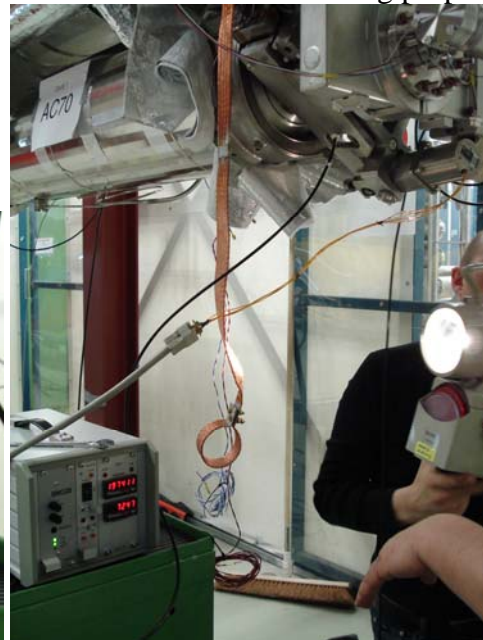
2 technicians ran tests at each tuner motor to insure that the motors are running properly.

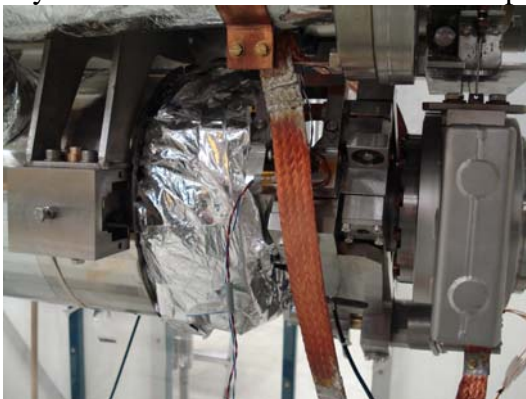
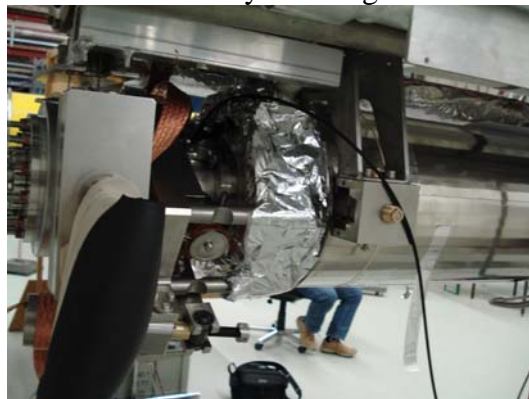
Cavity #1's insulation was trimmed and taped between the cavity #1 and gate valve.

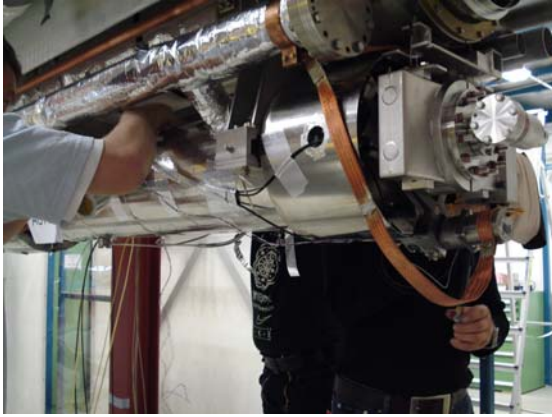
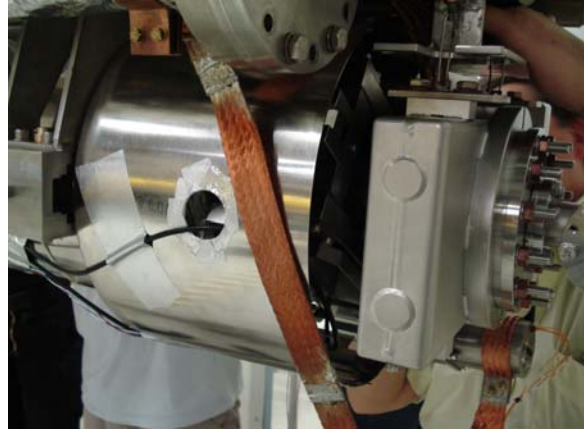
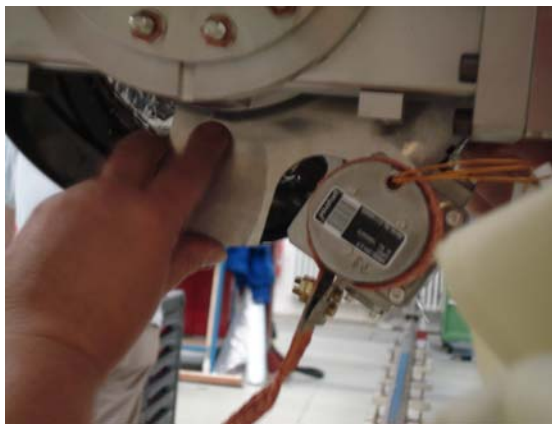
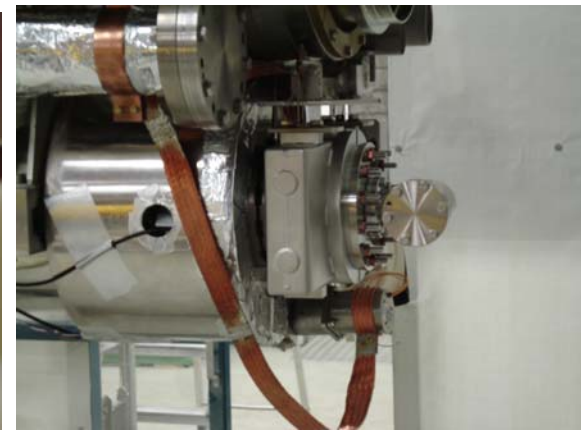
Technicians installed magnetic shields on Cavity #1 end between Cavity#1 and the gate valve. It was again difficult to fit the shields together. Technicians had to pry the interconnecting edges and they needed to modify some face piece shields around the gate valve and tuner motor. Some shield components were even cut into several pieces to help with the installation.

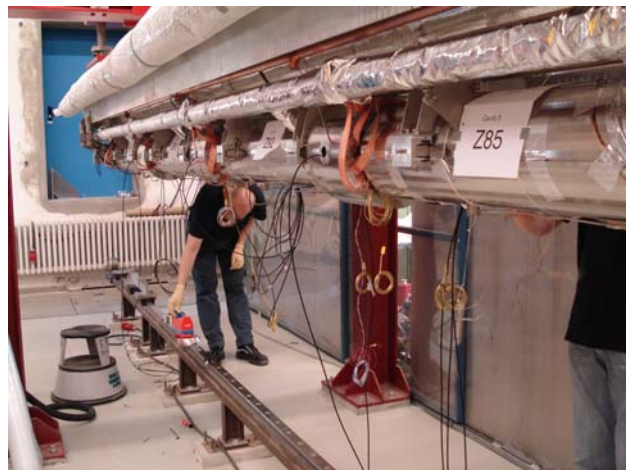
Technicians completed the magnetic shields installation and checked all the shielding around the cavity string. They made sure that all the cables and wires were taped properly to the shields.

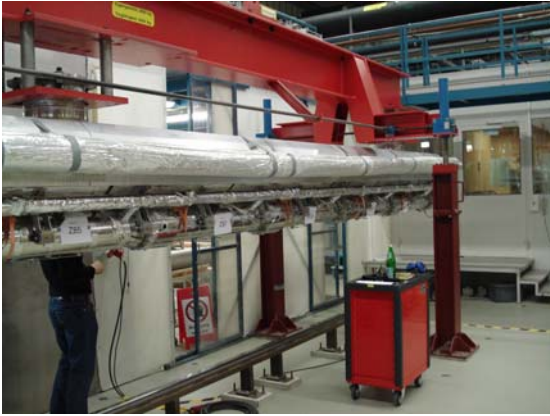
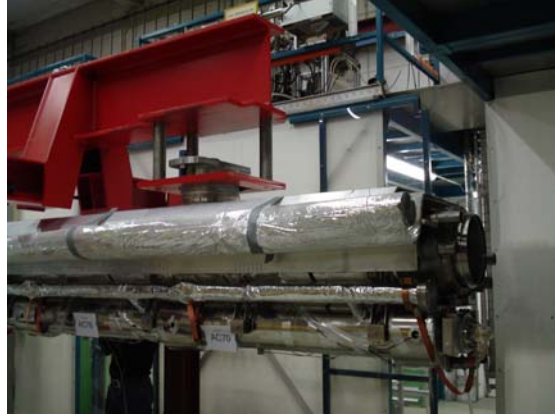
By the end of Day 12, the cold Mass was finally ready to be moved to the Big Bertha Fixture for the remainder of the assembly.
